School Assessment Report

District: Dolores RE-4A
School: Dolores MS/HS
Date: Mar 17, 2015

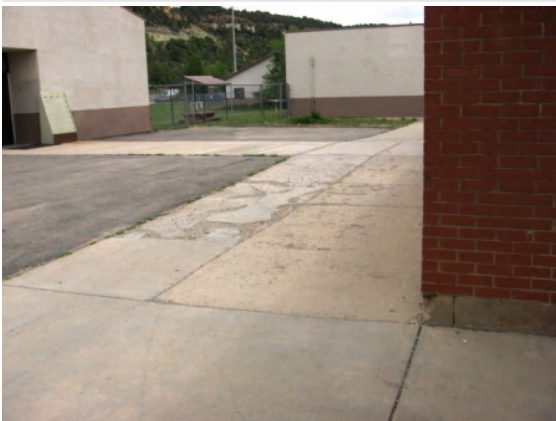
System: G2030 - Pedestrian Paving

Analysis: The system is in use and functioning with an estimated remaining service life as indicated in the report section "Condition/Replacement Budget Detail". The system was installed in 1996. It has a 50-year service life. However, in the assessment, it was found to be currently deficient.

Notes: The pedestrian paving is damaged and should be replaced.

Recommendation: The system should be replaced.

Correction: Replace damaged sidewalks 5'wide X 4"thick

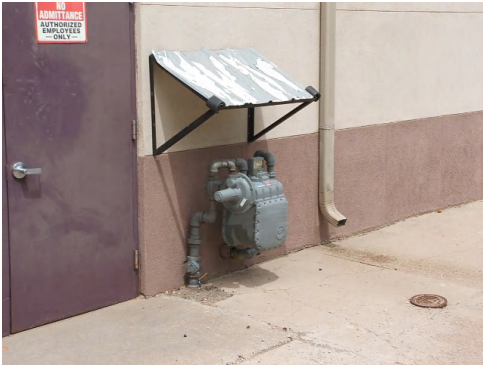
Analysis: The system is missing.

Distress: Missing

Recommendation: The system should be installed.

Correction: Replace and/or add fencing for security/appearance

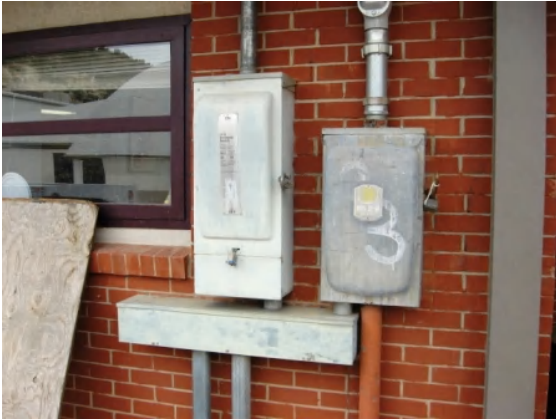
System: G4010 - Electrical Distribution

Analysis: The system age is either beyond expected life or does not meet its intended performance under the Guidelines. The system may be in service and functioning but it is recommended to be replaced due to probable increased condition budget needs, the potential failure of its components, or in order to meet the performance Guidelines for this system. The system was installed in 1968. It has a 30-year service life which expired in 1998.

Recommendation: The system should be replaced.

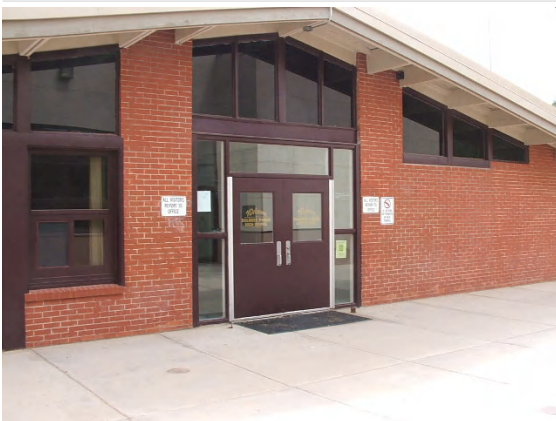
System: G4030 - Site Communication and Security

Analysis: The system is missing.

Location: Site
Distress: Missing
Category: Deferred Maintenance
Priority: 3 - 3 Necessary- 2-5 Yrs
Notes: Site communication and security does not exist and should be installed in the site.

Recommendation: The system should be installed.

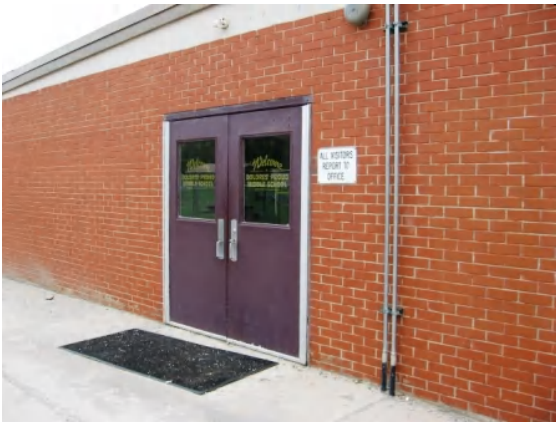
System: B2030 - Exterior Doors

Analysis: The system age is either beyond expected life or does not meet its intended performance under the Guidelines. The system may be in service and functioning but it is recommended to be replaced due to probable increased condition budget needs, the potential failure of its components, or in order to meet the performance Guidelines for this system. The system was installed in 1954. It has a 30-year service life which expired in 1984.

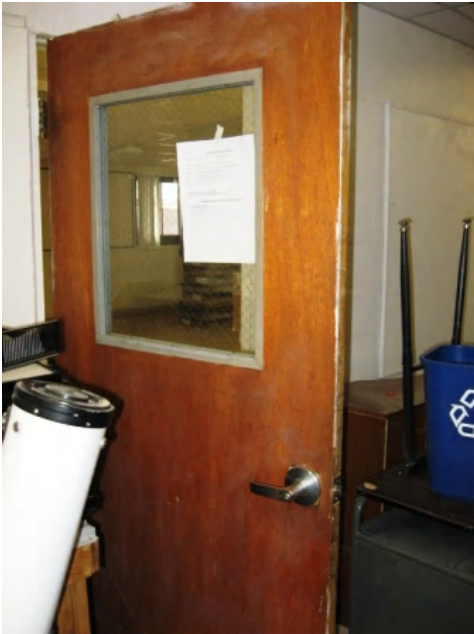
System: C1020 - Interior Doors

Analysis: The system age is either beyond expected life or does not meet its intended performance under the Guidelines. The system may be in service and functioning but it is recommended to be replaced due to probable increased condition budget needs, the potential failure of its components, or in order to meet the performance Guidelines for this system. The system was installed in 1954. It has a 40-year service life which expired in 1994.

Location: Main
Distress: Beyond Useful Life
Category: Deferred Maintenance
Priority: 3 - 3 Necessary- 2-5 Yrs
Correction: Renew System
Qty: 1-Ea.
Condition Budget: \$74,637

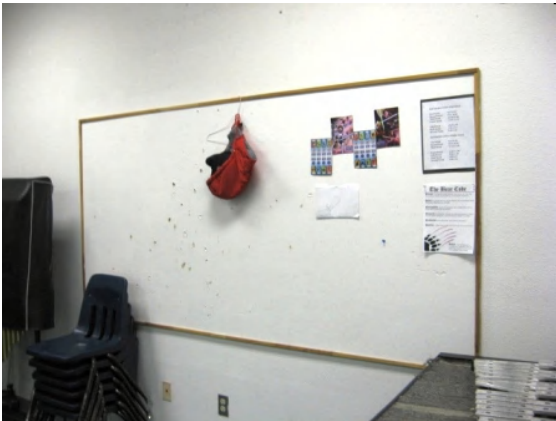
System: C1030 - Fittings

Analysis: The system age is either beyond expected life or does not meet its intended performance under the Guidelines. The system may be in service and functioning but it is recommended to be replaced due to probable increased condition budget needs, the potential failure of its components, or in order to meet the performance Guidelines for this system. The system was installed in 1954. It has a 20-year service life which expired in 1974.

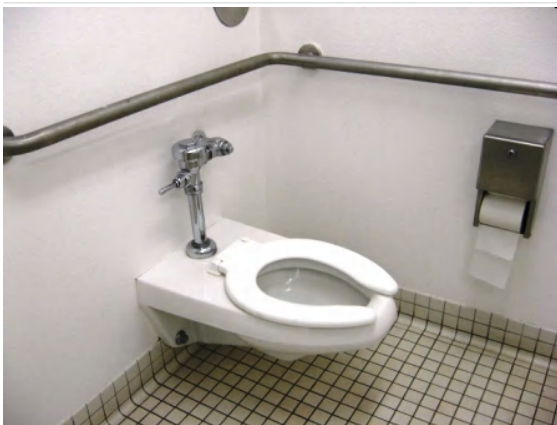
System: D2010 - Plumbing Fixtures

Analysis: The system age is either beyond expected life or does not meet its intended performance under the Guidelines. The system may be in service and functioning but it is recommended to be replaced due to probable increased condition budget needs, the potential failure of its components, or in order to meet the performance Guidelines for this system. The system was installed in 1954. It has a 30-year service life which expired in 1984.

Location: Main
Distress: Beyond Useful Life
Category: Deferred Maintenance
Priority: 3 - 3 Necessary- 2-5 Yrs
Correction: Renew System
Qty: 1-Ea.
Condition Budget: \$20,111

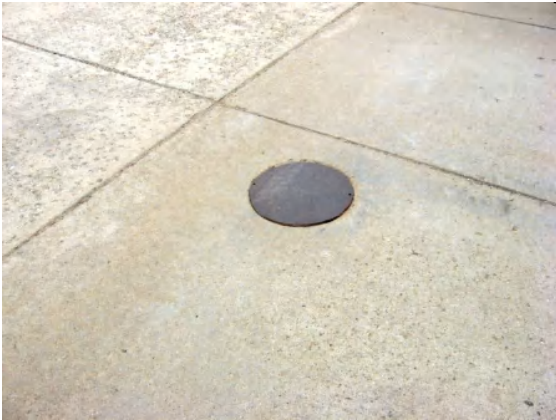
System: D2030 - Sanitary Waste

Analysis: The system age is either beyond expected life or does not meet its intended performance under the Guidelines. The system may be in service and functioning but it is recommended to be replaced due to probable increased condition budget needs, the potential failure of its components, or in order to meet the performance Guidelines for this system. The system was installed in 1954. It has a 30-year service life which expired in 1984.

Location: Main
Distress: Beyond Useful Life
Category: Deferred Maintenance
Priority: 3 - 3 Necessary- 2-5 Yrs
Correction: Renew System
Qty: 1-Ea.
Condition Budget: \$43,908

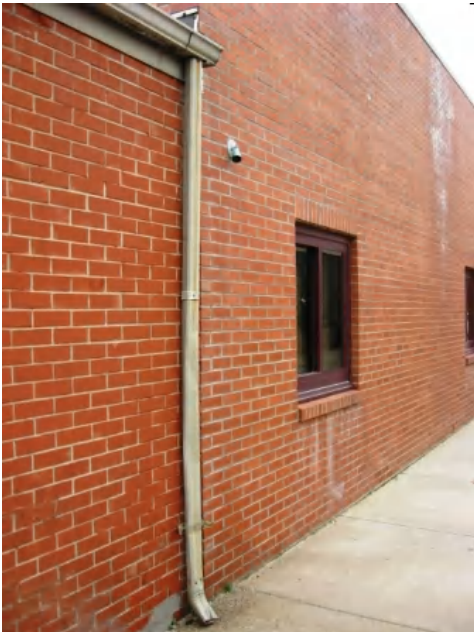
System: D2040 - Rain Water Drainage

Analysis: The system age is either beyond expected life or does not meet its intended performance under the Guidelines. The system may be in service and functioning but it is recommended to be replaced due to probable increased condition budget needs, the potential failure of its components, or in order to meet the performance Guidelines for this system. The system was installed in 1954. It has a 30-year service life which expired in 1984.

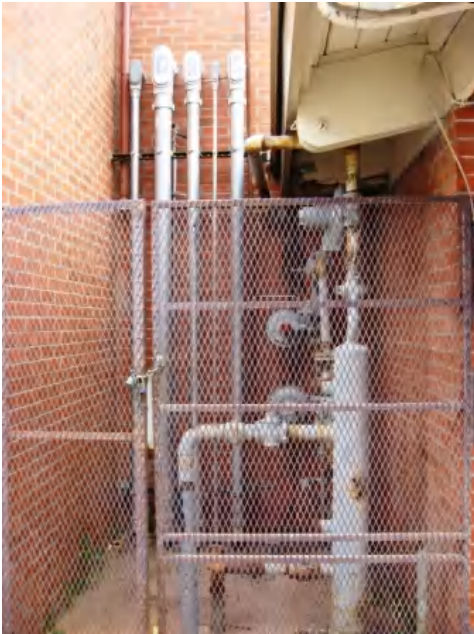
System: D2090 - Other Plumbing Systems

Analysis: The system age is either beyond expected life or does not meet its intended performance under the Guidelines. The system may be in service and functioning but it is recommended to be replaced due to probable increased condition budget needs, the potential failure of its components, or in order to meet the performance Guidelines for this system. The system was installed in 1954. It has a 20-year service life which expired in 1974.

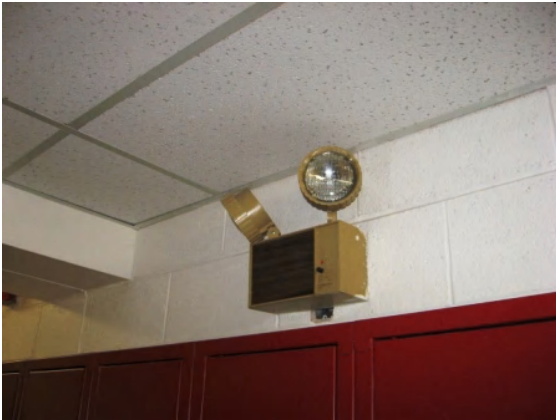
System: D5090 - Other Electrical Systems

Analysis: The system age is either beyond expected life or does not meet its intended performance under the Guidelines. The system may be in service and functioning but it is recommended to be replaced due to probable increased condition budget needs, the potential failure of its components, or in order to meet the performance Guidelines for this system. The system was installed in 1954. It has a 15-year service life which expired in 1969.

Location: Main
Distress: Beyond Useful Life
Category: Deferred Maintenance
Priority: 3 - 3 Necessary- 2-5 Yrs
Correction: Renew System
Qty: 1-Ea.
Condition Budget: \$11,130

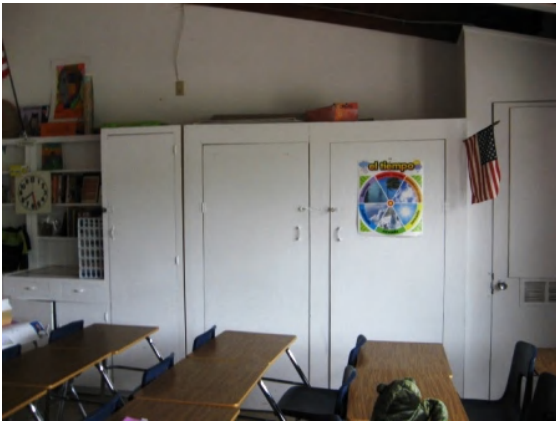
System: E2010 - Fixed Furnishings

Analysis: The system age is either beyond expected life or does not meet its intended performance under the Guidelines. The system may be in service and functioning but it is recommended to be replaced due to probable increased condition budget needs, the potential failure of its components, or in order to meet the performance Guidelines for this system. The system was installed in 1954. It has a 20-year service life which expired in 1974.

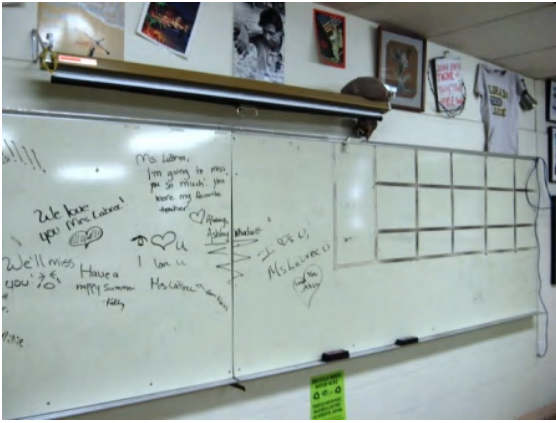
System: C1030 - Fittings

Analysis: The system age is either beyond expected life or does not meet its intended performance under the Guidelines. The system may be in service and functioning but it is recommended to be replaced due to probable increased condition budget needs, the potential failure of its components, or in order to meet the performance Guidelines for this system. The system was installed in 1971. It has a 20-year service life which expired in 1991.

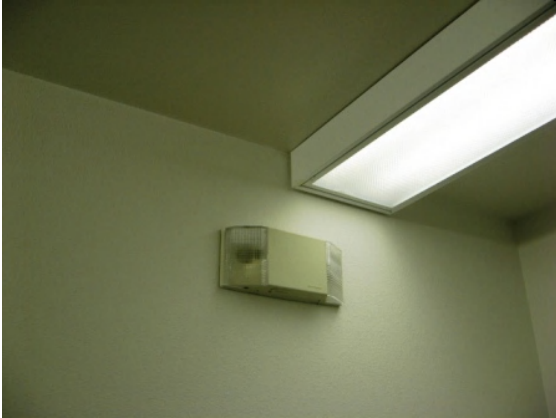
System: D5090 - Other Electrical Systems

Analysis: The system is missing.

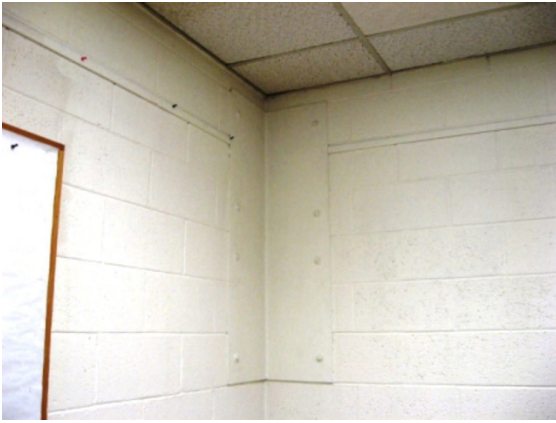
System: B2010 - Exterior Walls

Analysis: The system age is either beyond expected life or does not meet its intended performance under the Guidelines. The system may be in service and functioning but it is recommended to be replaced due to probable increased condition budget needs, the potential failure of its components, or in order to meet the performance Guidelines for this system. The system was installed in 1976. It has a 100-year service life which expired in 2009.

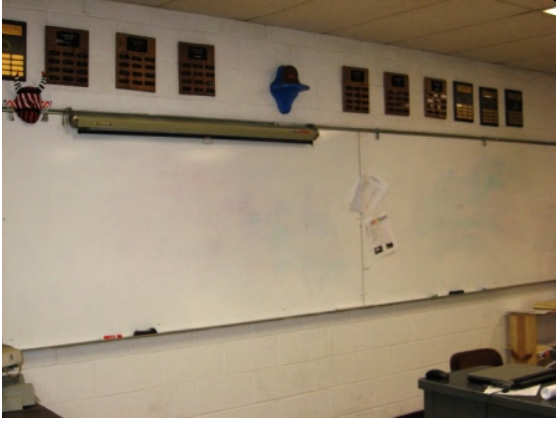
System: C1030 - Fittings

Analysis: The system age is either beyond expected life or does not meet its intended performance under the Guidelines. The system may be in service and functioning but it is recommended to be replaced due to probable increased condition budget needs, the potential failure of its components, or in order to meet the performance Guidelines for this system. The system was installed in 1976. It has a 20-year service life which expired in 1996.

Location: Science/Vo-Ag
Distress: Beyond Useful Life
Category: Deferred Maintenance
Priority: 3 - 3 Necessary- 2-5 Yrs
Correction: Renew System
Qty: 1-Ea.
Condition Budget: \$47,025

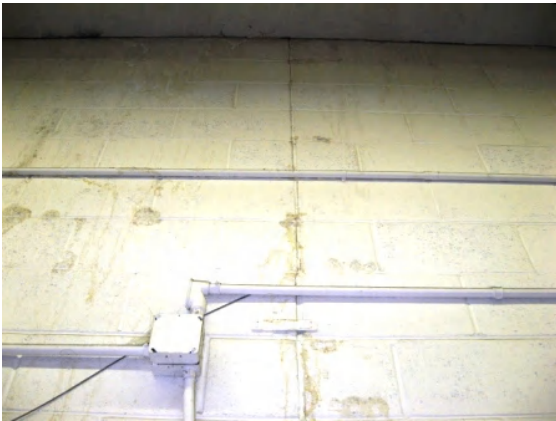
System: C3010 - Wall Finishes

Analysis: The system age is either beyond expected life or does not meet its intended performance under the Guidelines. The system may be in service and functioning but it is recommended to be replaced due to probable increased condition budget needs, the potential failure of its components, or in order to meet the performance Guidelines for this system. The system was installed in 1976. It has a 20-year service life which expired in 1996.

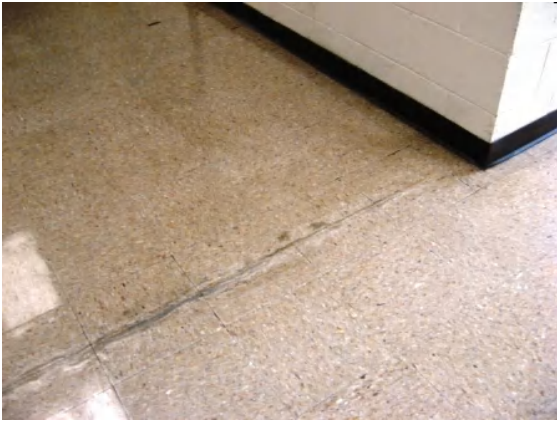
System: C3020 - Floor Finishes

Analysis: The system age is either beyond expected life or does not meet its intended performance under the Guidelines. The system may be in service and functioning but it is recommended to be replaced due to probable increased condition budget needs, the potential failure of its components, or in order to meet the performance Guidelines for this system. The system was installed in 1976. It has a 20-year service life which expired in 1996.

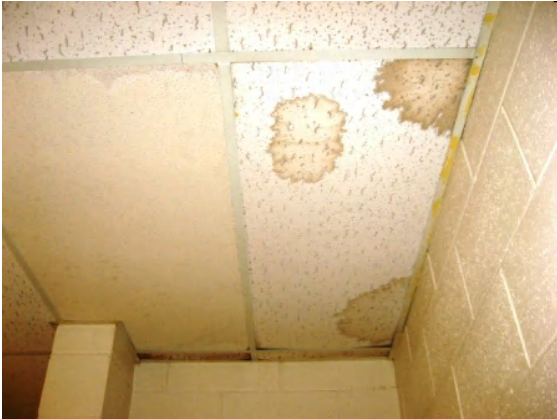
System: C3030 - Ceiling Finishes

Analysis: The system age is either beyond expected life or does not meet its intended performance under the Guidelines. The system may be in service and functioning but it is recommended to be replaced due to probable increased condition budget needs, the potential failure of its components, or in order to meet the performance Guidelines for this system. The system was installed in 1976. It has a 20-year service life which expired in 1996.

Location: Science/Vo-Ag
Distress: Beyond Useful Life
Category: Deferred Maintenance
Priority: 3 - 3 Necessary- 2-5 Yrs
Correction: Renew System
Qty: 1-Ea.
Condition Budget: \$101,994

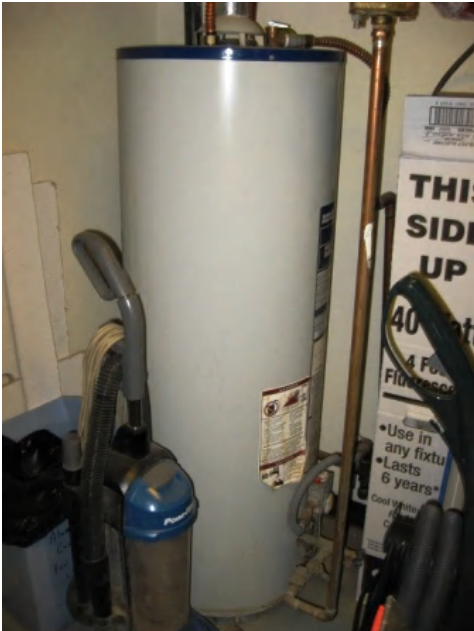
System: D2020 - Domestic Water Distribution

Analysis: The system age is either beyond expected life or does not meet its intended performance under the Guidelines. The system may be in service and functioning but it is recommended to be replaced due to probable increased condition budget needs, the potential failure of its components, or in order to meet the performance Guidelines for this system. The system was installed in 1976. It has a 30-year service life which expired in 2006.

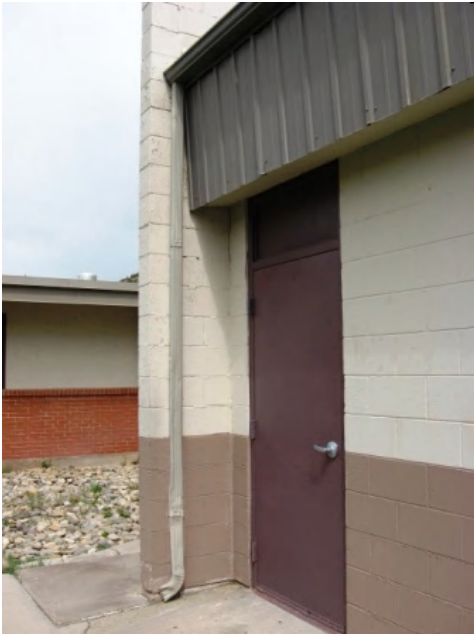
System: D2040 - Rain Water Drainage

Analysis: The system age is either beyond expected life or does not meet its intended performance under the Guidelines. The system may be in service and functioning but it is recommended to be replaced due to probable increased condition budget needs, the potential failure of its components, or in order to meet the performance Guidelines for this system. The system was installed in 1976. It has a 30-year service life which expired in 2006.

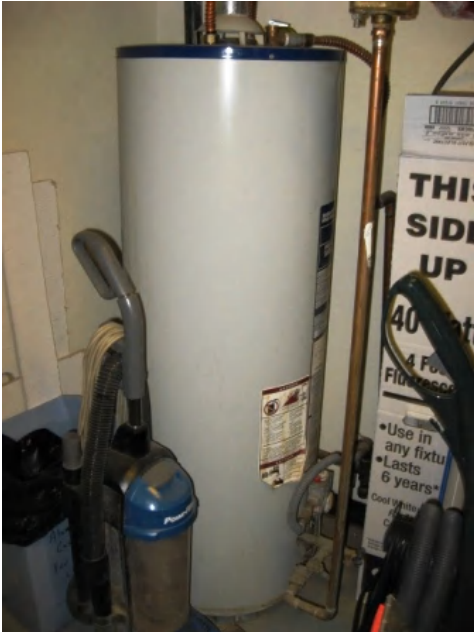
System: D2090 - Other Plumbing Systems

Analysis: The system age is either beyond expected life or does not meet its intended performance under the Guidelines. The system may be in service and functioning but it is recommended to be replaced due to probable increased condition budget needs, the potential failure of its components, or in order to meet the performance Guidelines for this system. The system was installed in 1976. It has a 20-year service life which expired in 1996.

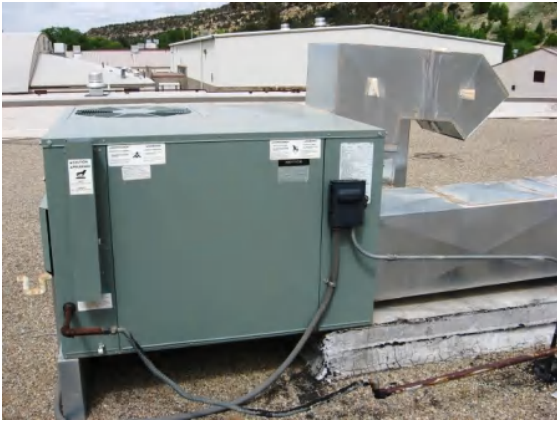
System: D3040 - Distribution Systems

Analysis: The system age is either beyond expected life or does not meet its intended performance under the Guidelines. The system may be in service and functioning but it is recommended to be replaced due to probable increased condition budget needs, the potential failure of its components, or in order to meet the performance Guidelines for this system. The system was installed in 1976. It has a 30-year service life which expired in 2006.

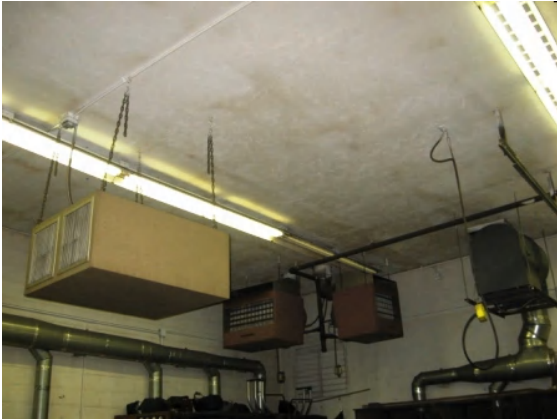
System: D3050 - Terminal & Package Units

Analysis: The system age is either beyond expected life or does not meet its intended performance under the Guidelines. The system may be in service and functioning but it is recommended to be replaced due to probable increased condition budget needs, the potential failure of its components, or in order to meet the performance Guidelines for this system. The system was installed in 1976. It has a 15-year service life which expired in 1991.

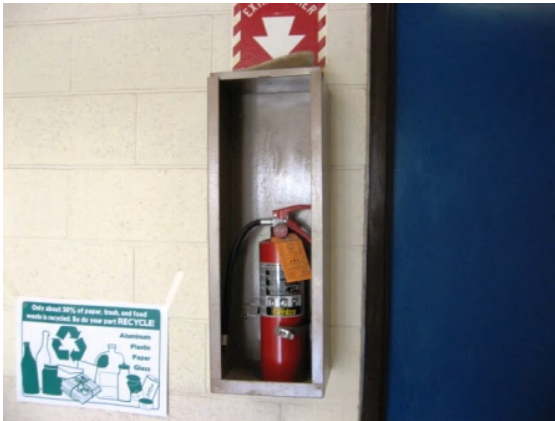
System: D4030 - Fire Protection Specialties

Analysis: The system age is either beyond expected life or does not meet its intended performance under the Guidelines. The system may be in service and functioning but it is recommended to be replaced due to probable increased condition budget needs, the potential failure of its components, or in order to meet the performance Guidelines for this system. The system was installed in 1976. It has a 15-year service life which expired in 1991.

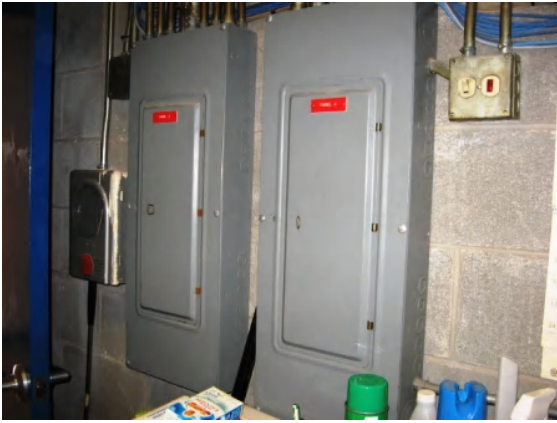
System: D5010 - Electrical Service/Distribution

Analysis: The system age is either beyond expected life or does not meet its intended performance under the Guidelines. The system may be in service and functioning but it is recommended to be replaced due to probable increased condition budget needs, the potential failure of its components, or in order to meet the performance Guidelines for this system. The system was installed in 1976. It has a 30-year service life which expired in 2006.

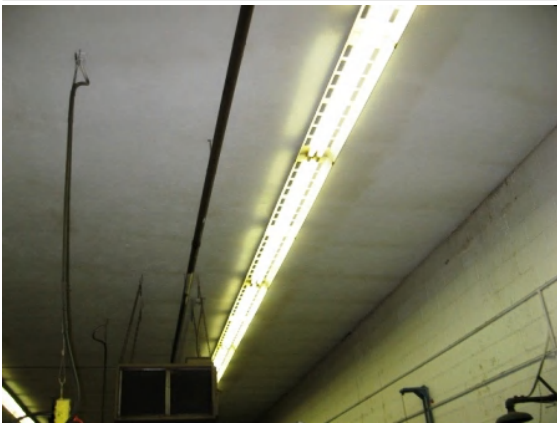
System: D5020 - Lighting and Branch Wiring

Analysis: The system age is either beyond expected life or does not meet its intended performance under the Guidelines. The system may be in service and functioning but it is recommended to be replaced due to probable increased condition budget needs, the potential failure of its components, or in order to meet the performance Guidelines for this system. The system was installed in 1976. It has a 30-year service life which expired in 2006.

Location: Science/Vo-Ag
Distress: Beyond Useful Life
Category: Deferred Maintenance
Priority: 3 - 3 Necessary- 2-5 Yrs
Correction: Renew System
Qty: 1-Ea.
Condition Budget: \$71,608

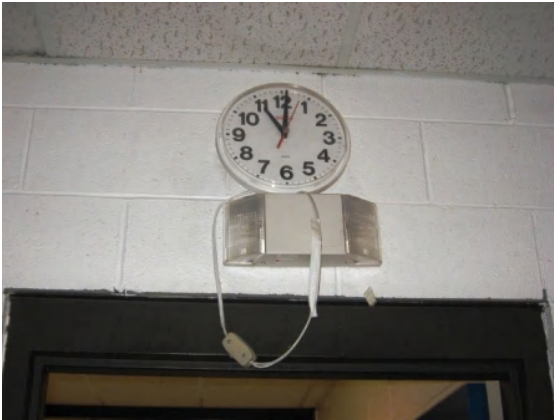
System: D5090 - Other Electrical Systems

Location: Science/Vo-Ag
Distress: Beyond Useful Life
Category: Deferred Maintenance
Priority: 3 - 3 Necessary- 2-5 Yrs
Correction: Renew System
Qty: 1-Ea.
Condition Budget: \$6,640
