# 2019 MASTER PLAN **DOLORES SCHOOL DISTRICT**

Dolores, Colorado  
August 15, 2019

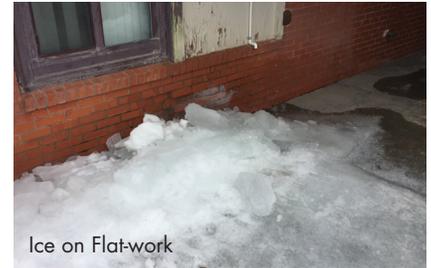
7. A new membrane roof was installed in 2015 to address areas of leaking. The adverse effect is all the snow captured on the roof slides off onto the concrete walkways around the gym causing maintenance and safety issues.

Ice on Flat-work

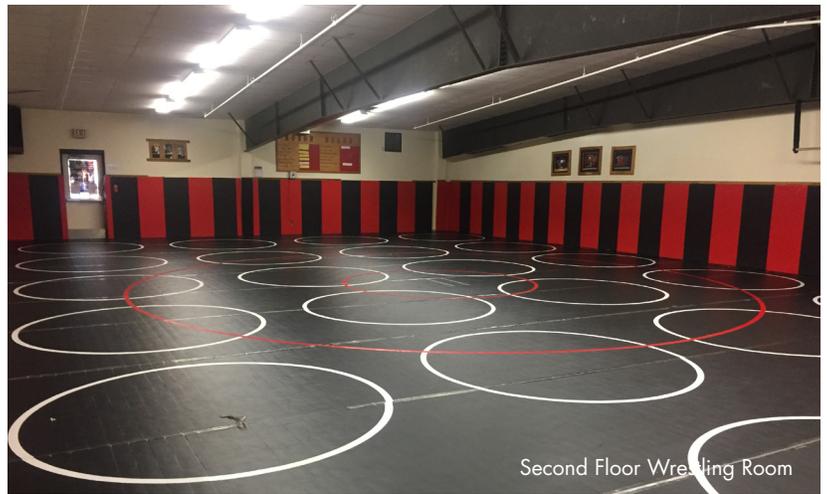
The lighting, electrical and mechanical systems in this building are in good condition and the building is sprinkled. All lighting fixtures were replaced in 2009 with high efficiency units under the Colorado State Governor's Energy Assistance Program. The building also includes a two-story area with a classroom and an equipment storage area on the main level and a non-ADA compliant wrestling room on the upper level.

Second Floor Wrestling Room

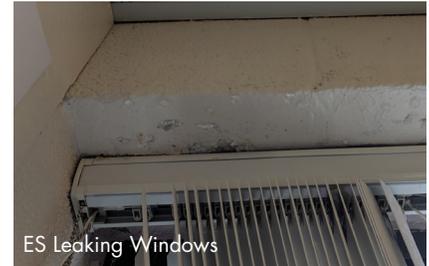
ES Leaking Windows

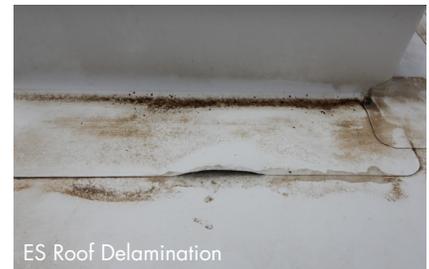
ES Roof Delamination

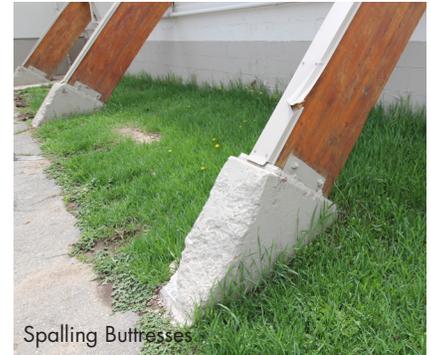
- Exterior concrete buttresses are deteriorating. Spalling is visible at multiple locations. This was discussed in the 2012 Master Plan and the deficiency has increased in severity.
- Cracking is present on the parapet of the south wall. Strapping has been added.

Spalling Buttresses

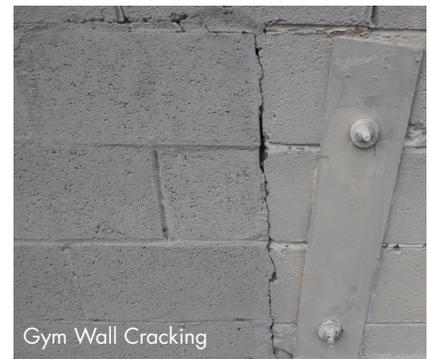
Gym Wall Cracking

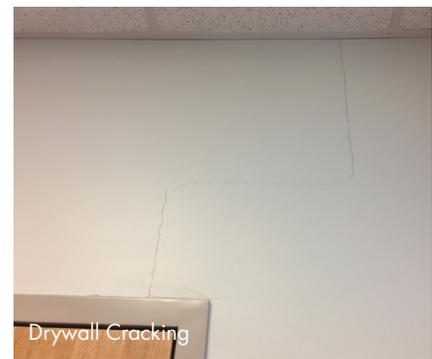
Drywall Cracking
