# 2022 AMENDMENTS TO 2019 DOLORES SCHOOL DISTRICT RE-4A FACILITIES MASTER PLAN

December 2022

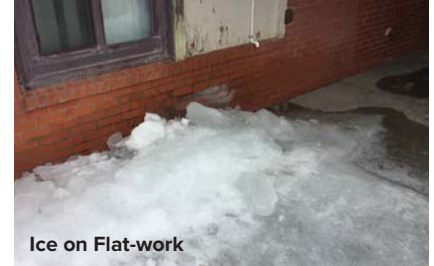
7. A new membrane roof was installed in 2015 to address areas of leaking. The adverse effect is all the snow captured on the roof slides off onto the concrete walkways around the gym causing maintenance and safety issues.

Ice on Flat-work

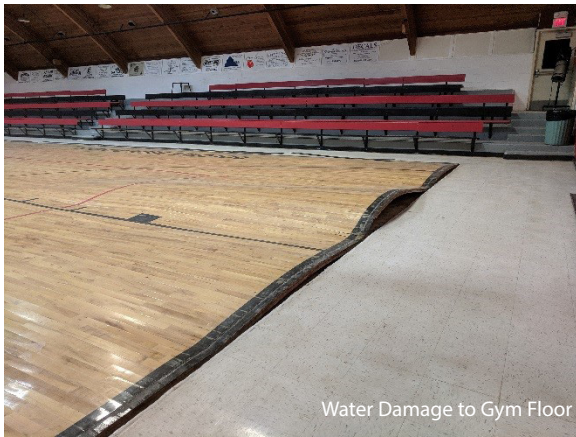
Water Damage to Gym Floor

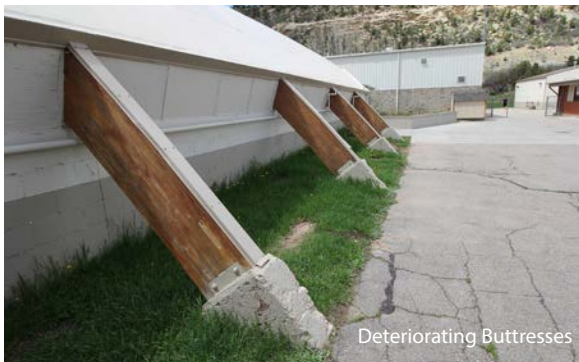
5. Acoustics are highly deficient for this building to be used as a performance space.
6. Concrete buttresses that support the roof structure are deteriorating.

Deteriorating Buttresses

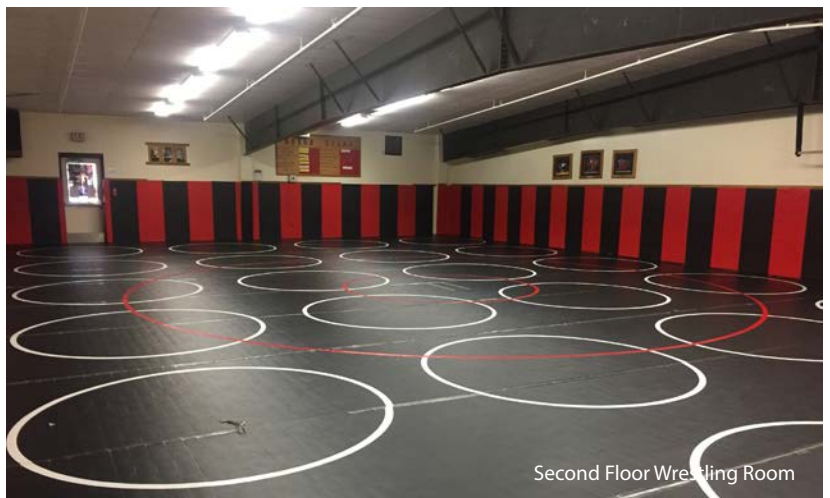
Second Floor Wrestling Room

The lighting, electrical and mechanical systems in this building are in good condition and the building is sprinkled. All lighting fixtures were replaced in 2009 with high efficiency units under the Colorado State Governor's Energy Assistance Program. The building also includes a two-story area with a classroom, weight room and an equipment storage area on the main level and a non-ADA compliant wrestling room on the upper level.

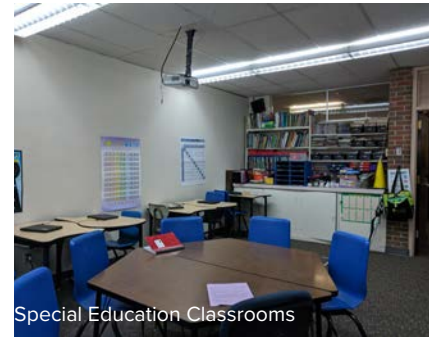
Special Education Classrooms

1. At an average of 380 sf per room, the Elementary School special education classrooms are far short of the CDE minimum space standards of 675 sf and are inadequate for the learning needs of special education. Students do not have proper space to move about the room and teachers are unable to safely handle any incidents during a full class. The smallest SPED Classroom only allows for 8 students based on the 37 sf requirement designated by the CDE, the largest SPED Classroom Size is 10 students. These classrooms are not all equipped with functioning sinks, further hindering teacher's ability to address classroom incidents.

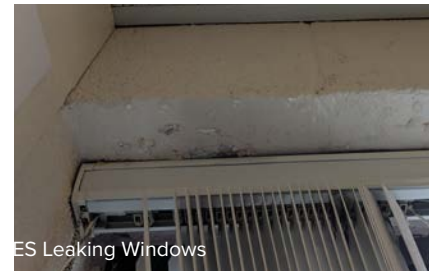
ES Leaking Windows

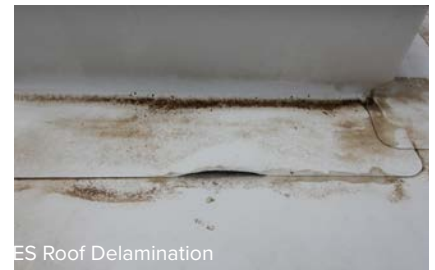
ES Roof Delamination

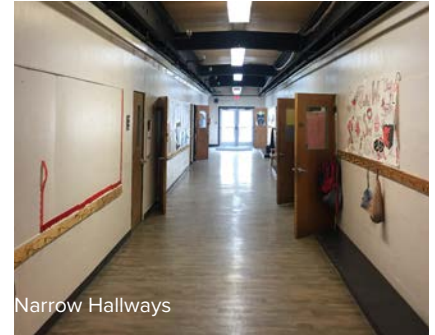
- The Middle School is designed as a long narrow double loaded corridor which is congested with students using the circulation space for group work. This is detrimental to the quality of education, creates long distances between building egress points, and presents a safety hazard.

Narrow Hallways

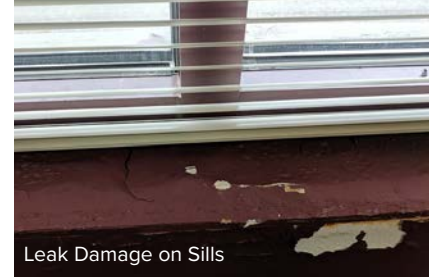
Leak Damage on Sills

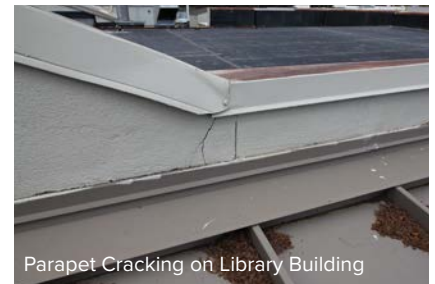
Parapet Cracking on Library Building

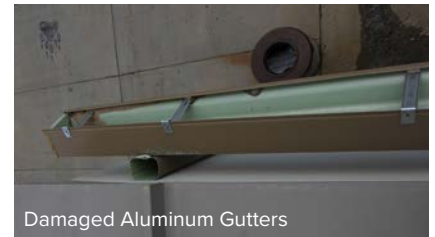
Damaged Aluminum Gutters

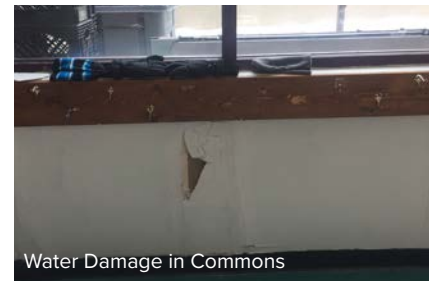
Water Damage in Commons

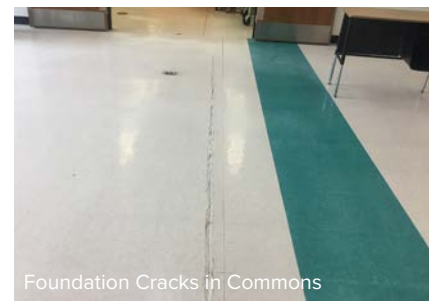
Foundation Cracks in Commons

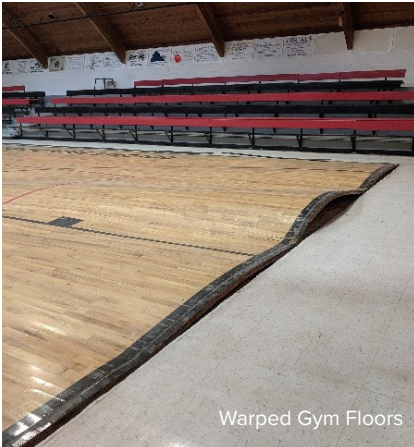
Warped Gym Floors

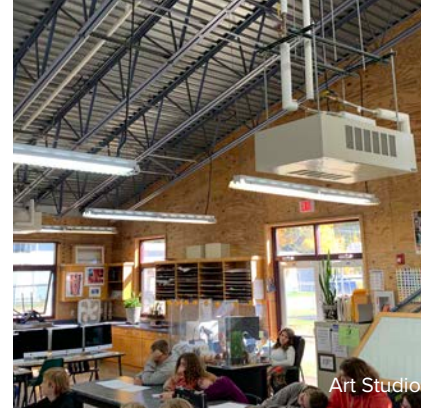
Art Studio

- Ventilation is deficient in Art room. Odors are often present. It is recommended a unit ventilator be installed. Noted in the 2012 Master Plan as well.
- Dust collection system is located in the Electrical Room in violation of code. The system should be relocated outside. Dust from the system puts electrical equipment at risk.
- Boiler system is not appropriately sized for the size of the building. In the morning it takes four hours for system to reach 70 degrees.
- Boiler system is at the end of projected lifespan.
- No known deficiencies with plumbing system.
- The building becomes extremely hot in spring and fall. Cooling should be added.
- The wood shop does not have enough electrical receptacles.
