School Assessment Report

District: Dolores RE-4A
School: Dolores MS/HS
Date: Mar 17, 2015

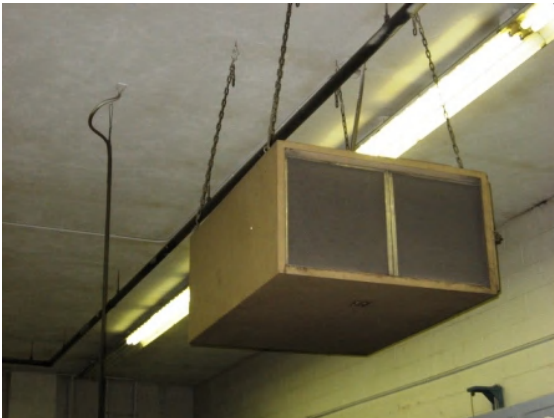
Analysis: The system age is either beyond expected life or does not meet its intended performance under the Guidelines. The system may be in service and functioning but it is recommended to be replaced due to probable increased condition budget needs, the potential failure of its components, or in order to meet the performance Guidelines for this system. The system was installed in 1976. It has a 30-year service life which expired in 2006.

Deficiency

Location: Science/Vo-Ag
Distress: Beyond Useful Life
Category: Deferred Maintenance
Priority: 3 - 3 Necessary- 2-5 Yrs
Correction: Renew System
Qty: 1-Ea.
Condition Budget: \$115,624

Recommendation: The system should be replaced.
