# 2019 MASTER PLAN **DOLORES SCHOOL DISTRICT**

Dolores, Colorado  
August 15, 2019

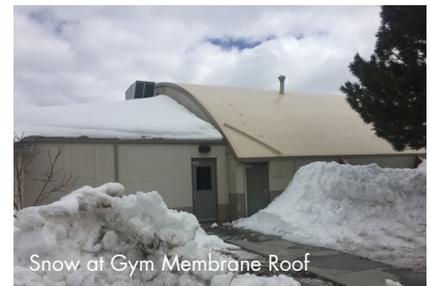
7. A new membrane roof was installed in 2015 to address areas of leaking. The adverse effect is all the snow captured on the roof slides off onto the concrete walkways around the gym causing maintenance and safety issues.

Snow at Gym Membrane Roof

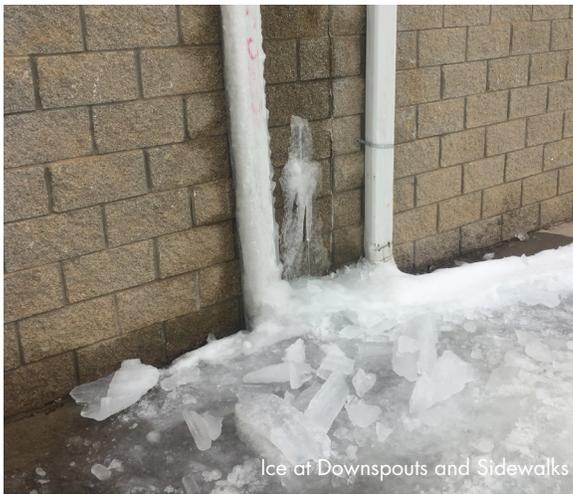
The exterior walls are cast-in-place concrete. An EPDM membrane roof was installed in 2015. Snow slides off the barrel vault and piles up on adjacent walkways and against the exterior walls causing building damage and safety issues. The roof has no drainage system or snow guards.

Ice at Downspouts and Sidewalks

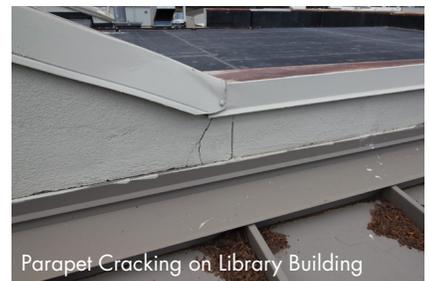
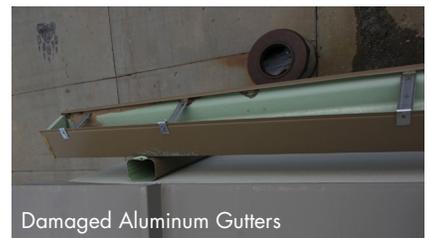
- Foundation settlement and visible cracking is a primary concern of the building.

- Cracking in the slab and exterior walls is visible in the cafeteria. Structural remediation should occur at the foundation to prevent further damage.
- Storefront window systems are compromised due to settlement and moisture is visible in between glazing.
- Library windows on the south wall show signs of leaking at the sill and continue to damage finishes. This should be resolved as part of a renovation.
- Areas of deterioration are visible on the stucco due to water infiltration.
- The standing seam Library roof appears to be in good condition. Aluminum gutters are regularly destroyed due to snow sliding off the roof.
- The Cafeteria membrane roof is beyond its functional lifespan and showing signs of deterioration.
- The top of wall coping is corroded and the sealant is failing.

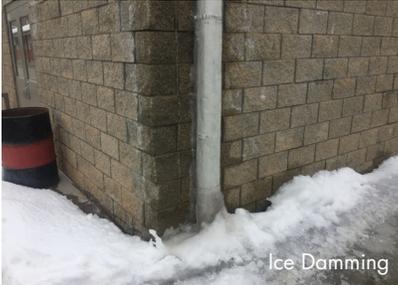
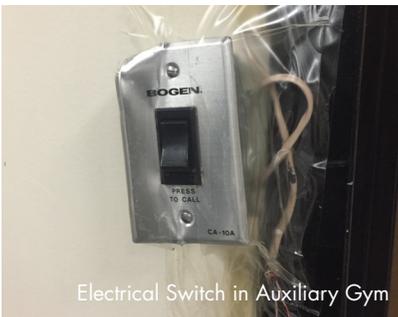
- Efflorescence is visible throughout the concrete block on the lower level of the exterior walls, suggesting the connection between the top of block and metal stud wall above is improperly flashed and allowing moisture to enter the wall assembly. Its unknown how long this has been happening and could have caused unseen deterioration or negative effects to indoor air quality based on the persistence of moisture within the wall cavity.
- The aluminum gutters and downspouts are incapable of handling large snow melts. Gutters are destroyed and replaced annually. On the north elevation of the building, ice damming is constant posing a safety risk to students walking on the adjacent concrete path from the bus drop-off.

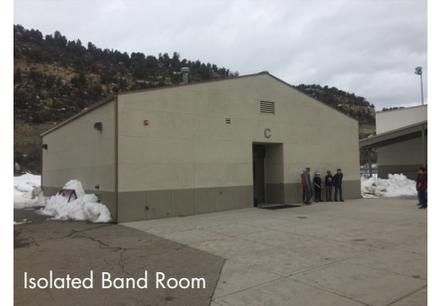
- Lighting is florescent and should be upgraded to LED.
- The HVAC system has no cooling or ventilation.
- The building contains one sink and no other plumbing fixtures. The lack of dedicated restrooms requires students to travel outside—typically to the opposite side of campus—to use restrooms in the Secondary School.
- The building is sprinklered and connected directly to the city main water line. Pressure is inconsistent.
- Exterior gas connection is protected from falling snow from the roof by a small shed roof that could be compromised in a large snow event.

Isolated Band Room

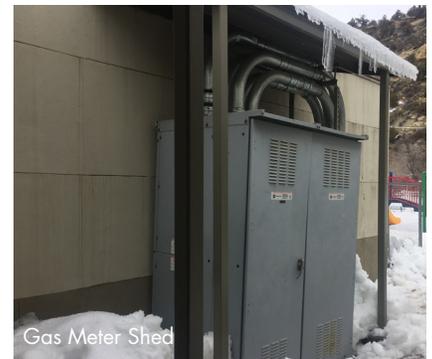
- Lack of cooling is a problem and negatively affects the learning environment.
- RTU's should be rebalanced as positive pressure is so great when in operation it is difficult to keep exterior doors closed. This compromises security of the building.
- Maintenance only runs forced air heating in periods of extreme cold.
- No protection on the external gas connection to the building.

Gas Meter Shed

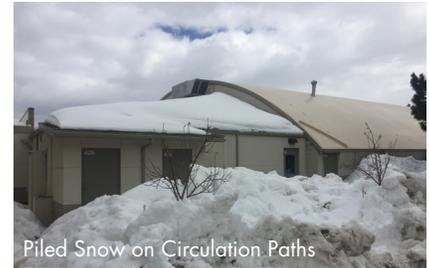
Piled Snow on Circulation Paths

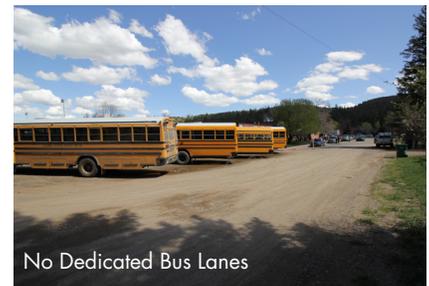
- There is no organization to the bus and vehicle loading because no infrastructure exists for separation. The lack of dedicated bus lanes and separated parking is a code violation and does not meet CDE requirements. Vehicles are forced to stop in the public right-of-way impacting travel flow around the campus.

No Dedicated Bus Lanes

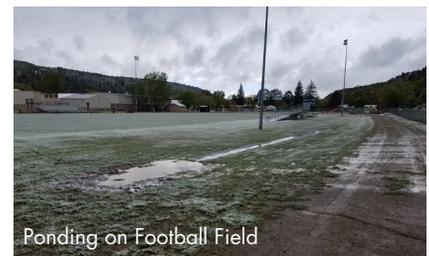
- The football field and recreation fields are located on the north edge of campus and are vulnerable to external threats. Site grading is inadequate and ponding on the fields is present after weather events.
- The site does not allow room for is a CHSAA compliant track.

Ponding on Football Field

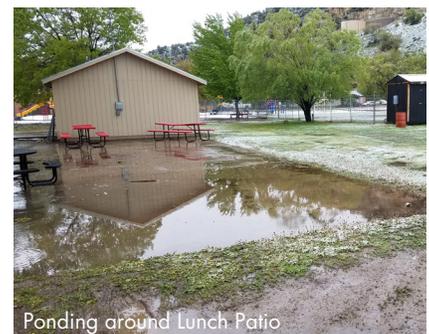
- The preschool has a small playground with cedar chip surfacing and a small grass field surrounded by residential lots with exposure to the bluff.
- Directly east of the Elementary playground is an outdoor lunch area with a concrete pad and picnic tables. Due to grading and poor site drainage, this pad regularly floods after rain events.

Ponding around Lunch Patio
