# 2022 AMENDMENTS TO 2019 DOLORES SCHOOL DISTRICT RE-4A FACILITIES MASTER PLAN

December 2022

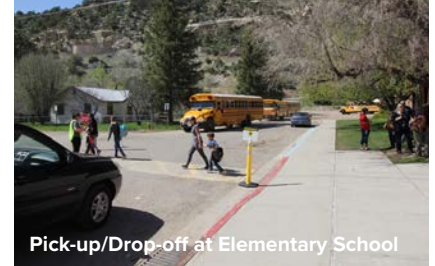
1. The Assessment identifies that the bus loading and unloading zones do not meet CDE guidelines, and confirmed the parent drop-off zone is located on-site. In fact, the mixing of parent drop-off, staff parking, and bus drop-off all occur simultaneously on the public street at the Elementary and Middle School/ High School and poses a safety hazard to students walking to and from school from the adjacent neighborhood and requires school staff resources to coordinate traffic within the congested public right-of-way.
2. There is not a security system around the campus and there is minimal site lighting. For a larger campus with a significant amount of entry points into each building in which students and staff are constantly traveling between, this also generates a threat for outsiders to enter the campus unidentified

Pick-up/Drop-off at Elementary School

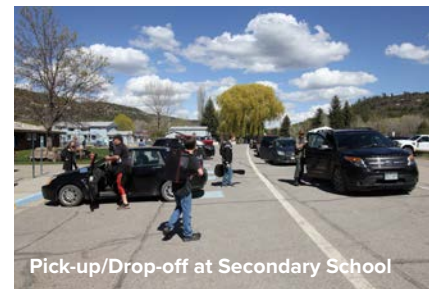
Pick-up/Drop-off at Secondary School

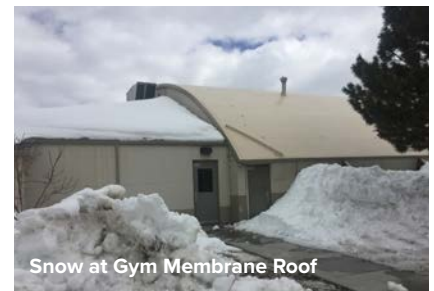
7. A new membrane roof was installed in 2015 to address areas of leaking. The adverse effect is all the snow captured on the roof slides off onto the concrete walkways around the gym causing maintenance and safety issues.

Snow at Gym Membrane Roof

The exterior walls are cast-in-place concrete. An EPDM membrane roof was installed in 2015. Snow slides off the barrel vault and piles up on adjacent walkways and against the exterior walls causing building damage and safety issues. The roof has no drainage system or snow guards.

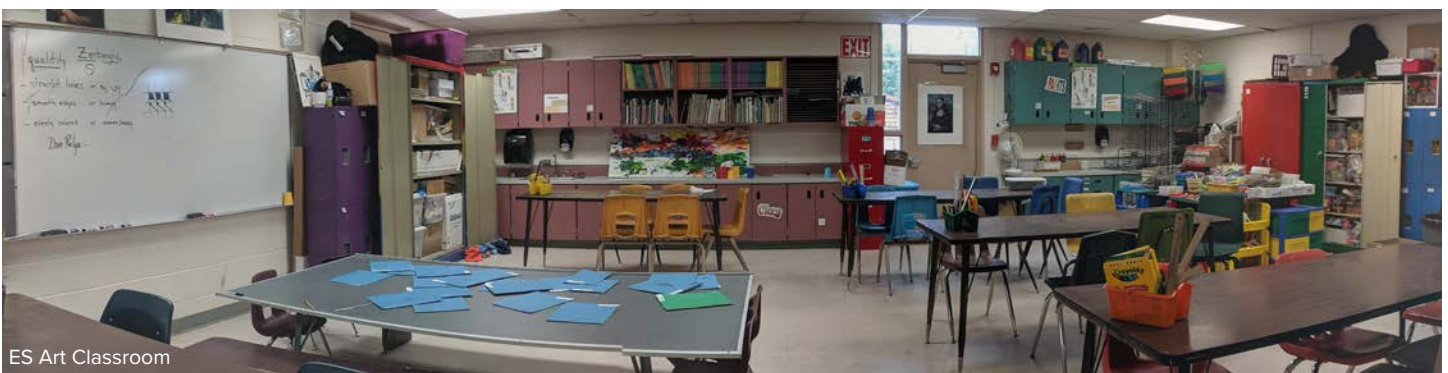
ES Art Classroom

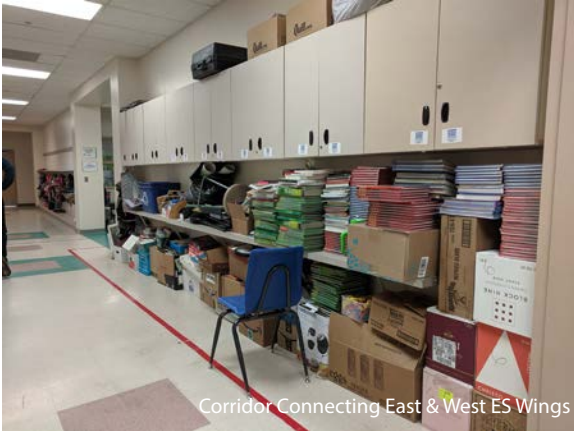
Corridor Connecting East & West ES Wings

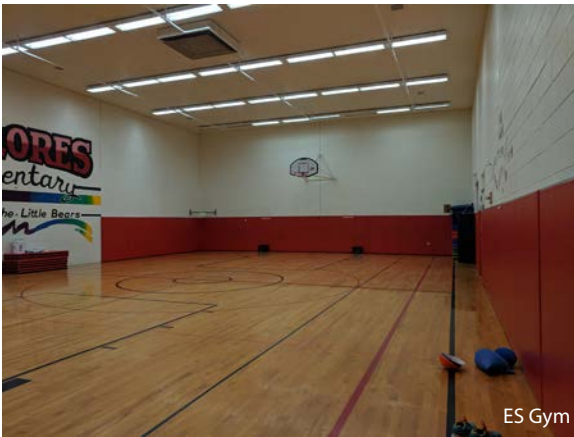
ES Gym

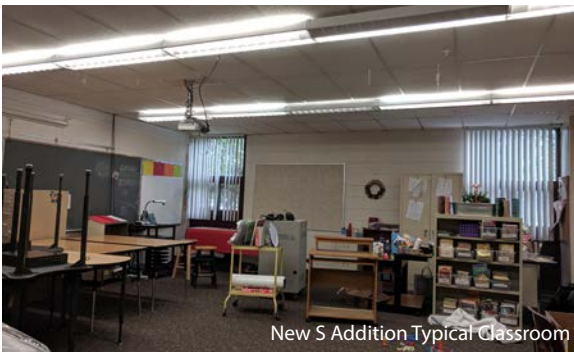
New S Addition Typical Classroom

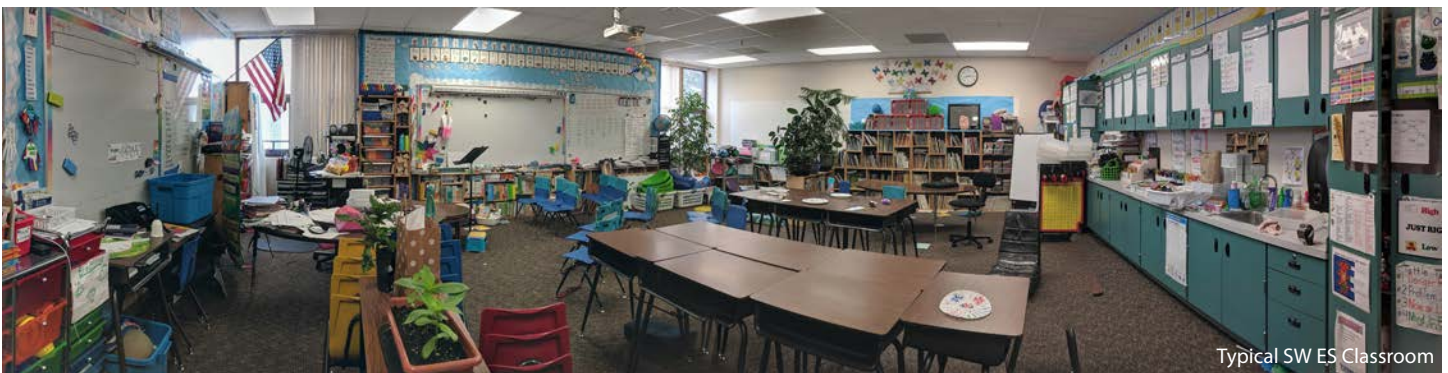
Typical SW ES Classroom

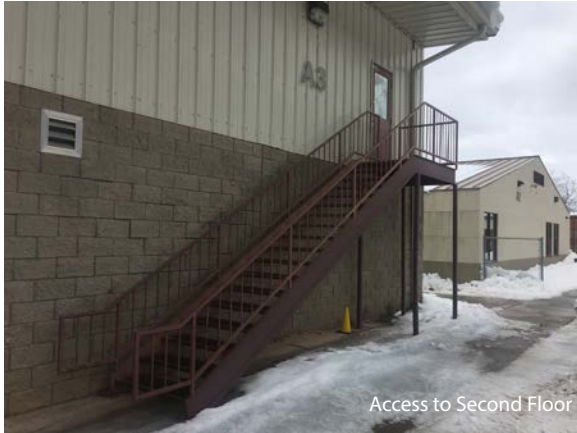
Access to Second Floor

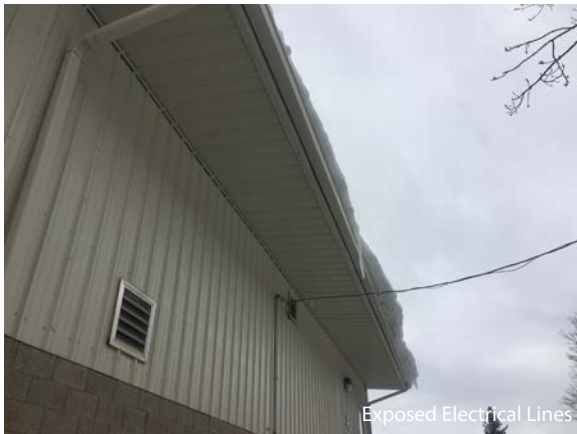
Exposed Electrical Lines

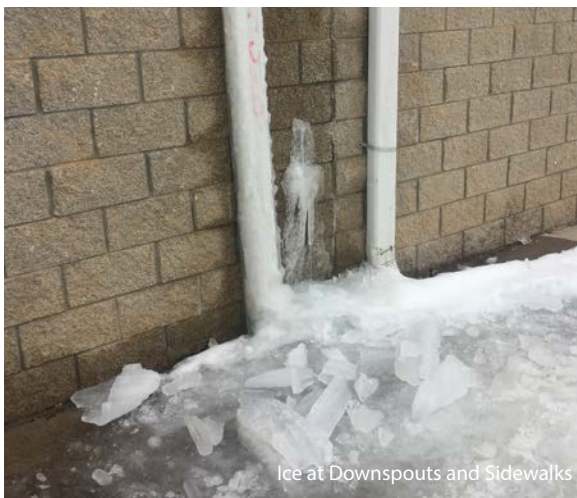
Ice at Downspouts and Sidewalks

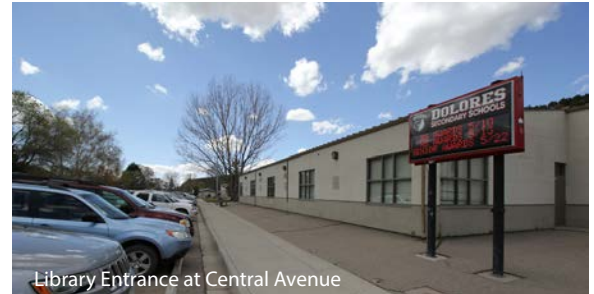
Library Entrance at Central Avenue

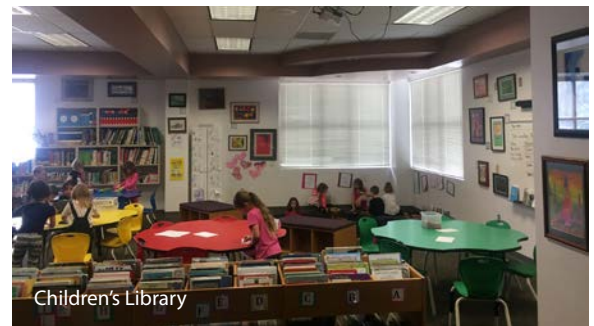
Children's Library

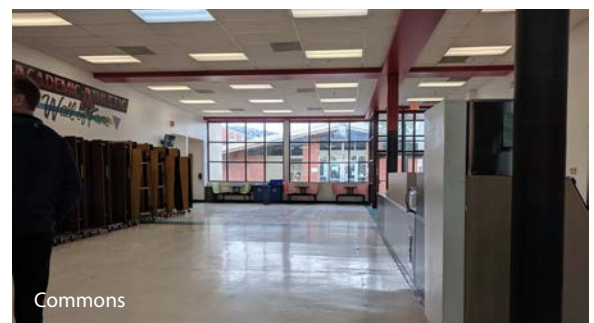
Commons

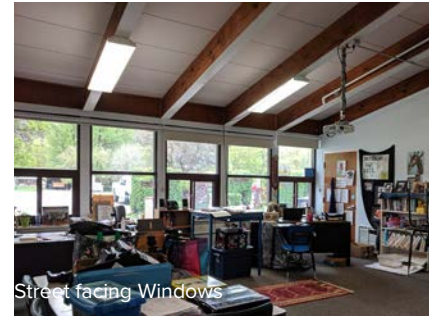
Street facing Windows

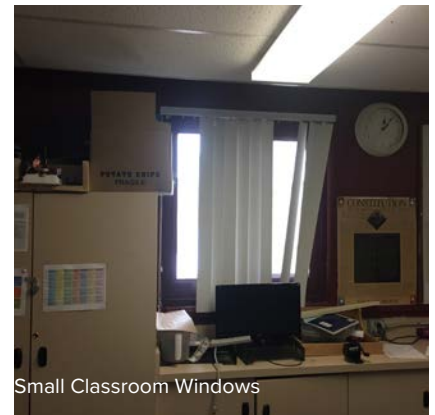
Small Classroom Windows

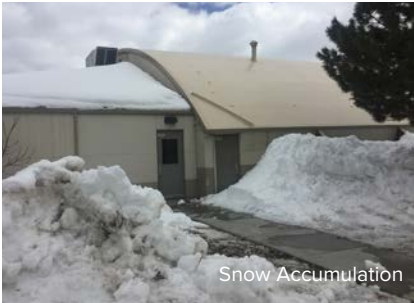
- A membrane roof was installed in 2015 to address leaking. Due to the barrel vault shape of the building, snow slides off the smooth membrane roof and accumulates against the exterior walls and on adjacent sidewalks causing constant safety and maintenance challenges.

Snow Accumulation

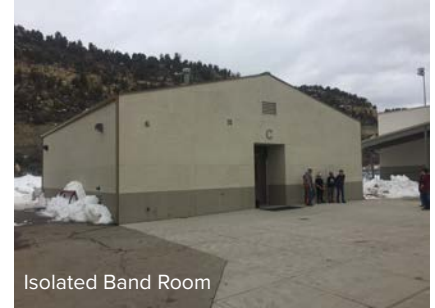
Isolated Band Room

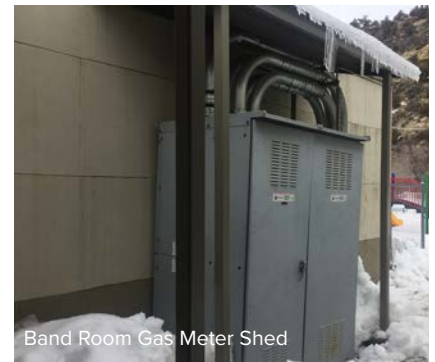
Band Room Gas Meter Shed

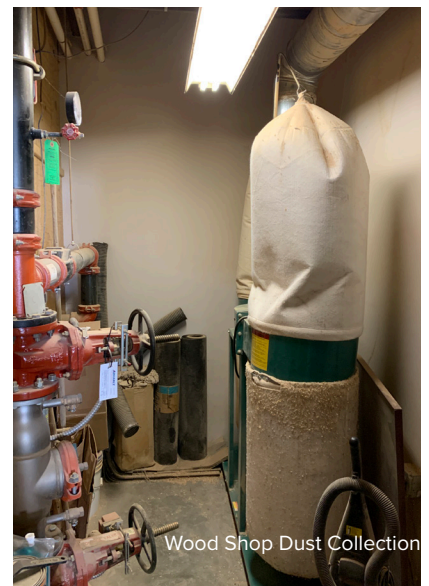
- Ventilation is deficient in Art room. Odors are often present. It is recommended a unit ventilator be installed. Noted in the 2012 Master Plan as well.
- Dust collection system is located in the Electrical Room in violation of code. The system should be relocated outside. Dust from the system puts electrical equipment at risk.
- Boiler system is not appropriately sized for the size of the building. In the morning it takes four hours for system to reach 70 degrees.
- Boiler system is at the end of projected lifespan.
- No known deficiencies with plumbing system.
- The building becomes extremely hot in spring and fall. Cooling should be added.
- The wood shop does not have enough electrical receptacles.

Wood Shop Dust Collection

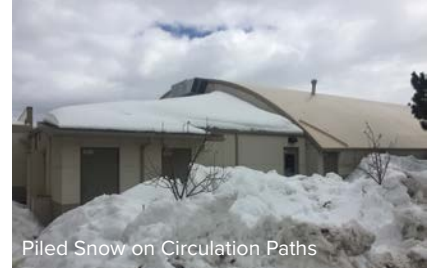
Piled Snow on Circulation Paths

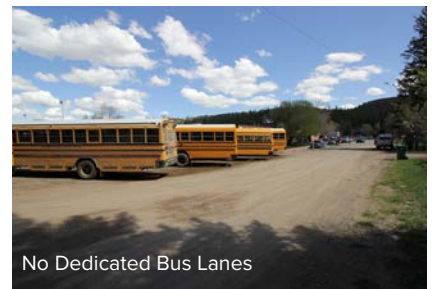
No Dedicated Bus Lanes

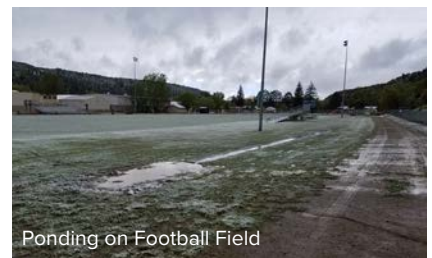
Ponding on Football Field

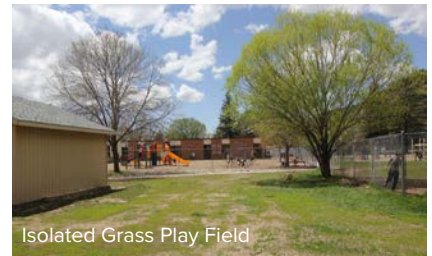
Isolated Grass Play Field

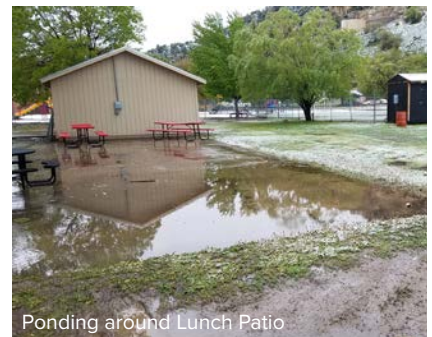
- The preschool has a small playground with cedar chip surfacing and a small grass field surrounded by residential lots with exposure to the bluff.
- Directly east of the Elementary playground is an outdoor lunch area with a concrete pad and picnic tables. Due to grading and poor site drainage, this pad regularly floods after rain events.

Ponding around Lunch Patio
